**DEPARTMENT OF TRANSPORTATION****DIVISION OF ENGINEERING SERVICES**

Office of Structural Materials

Contract #: 04-0120F4Cty: SF/ALA Rte: 80 PM: 13.2/13.9File #: 69.28**WELDING INSPECTION REPORT****Resident Engineer:** Pursell, Gary**Address:** 333 Burma Road**City:** Oakland, CA 94607**Report No:** WIR-004047**Date Inspected:** 31-Aug-2008**Project Name:** SAS Superstructure**OSM Arrival Time:** 1330**Prime Contractor:** American Bridge/Fluor Enterprises, a JV**OSM Departure Time:** 2230**Contractor:** Zhenhua Port Machinery Company, Ltd (ZPMC), Changxing Island **Location:** Shanghai, China**CWI Name:** See below**CWI Present:** Yes No**Inspected CWI report:** Yes No N/A**Rod Oven in Use:** Yes No N/A**Electrode to specification:** Yes No N/A**Weld Procedures Followed:** Yes No N/A**Qualified Welders:** Yes No N/A**Verified Joint Fit-up:** Yes No N/A**Approved Drawings:** Yes No N/A**Approved WPS:** Yes No N/A**Delayed / Cancelled:** Yes No N/A**Bridge No:** 34-0006**Component:** OBG Fabrication**Summary of Items Observed:**

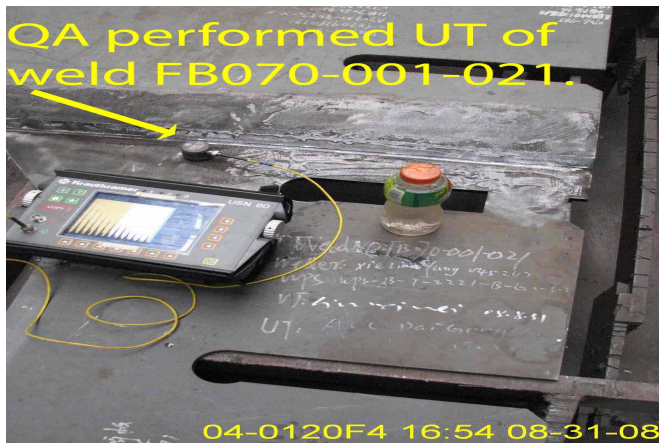
ZPMC notification of witness inspection document #00950 dated 8-31-2008 states that ZPMC QC inspection personnel will be conducting final ultrasonic inspections of floor beam welds in bay #8. Following ZPMC ultrasonic personnel accepting ultrasonic inspections of these welds the QA Inspector performed ultrasonic inspection of approximately 10% length of floor beam welds FB070-001-021, FB071-001-006, FB064-002-021, FB065-001-006, FB066-001-021, FB063-003-021, FB069-001-006, FB003-115-006 and FB064-003-002. The QA Inspector observed the welds appear to comply with project specifications. See the TL6027 ultrasonic test report for additional information.
